MUNICIPALITY OF ANCHORAGE
DEPARTMENT OF PUBLIC WORKS
CONSTRUCTION DIVISION

SOILS LOG

LOCATION Golden View Dr. 1/8 West of Golden View Dr.
500' North of E. Karamia Dr.
COMMENTS Test hole terminated in large cobbles

HOLE NO. 2
DATE 12/14/85
BY D.W. Miller
DEPTH 7.5'
WATER TABLE None

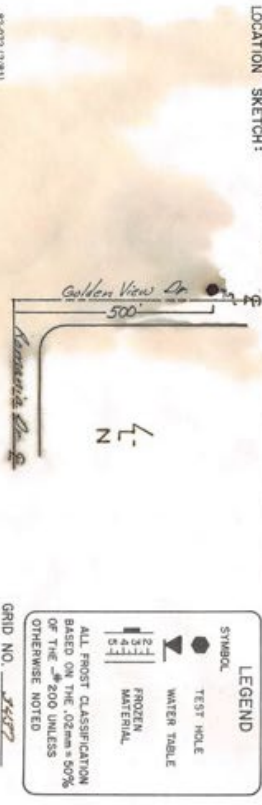
DEPTH	UNIFIED CLASS	FROST GROUP	DESCRIPTION
0			
2-8	SW/SH	F2	Excavation - Gravelly Sand (65%) w/ silt (10%)
EX-502			Material - Gravelly Sand w/ silt & clayey (10%)
2-8	SM	F2	Thin - Silty clayey sand / Moisture = 2.5%
EX-503			Occasional cobbles (20%) / High clayey
			(50%) (50%) (10%)
2-C	SW/SH	F2	Remain - Gravelly Sand w/ silt / Moisture = 4.5%
EX-504			Occasional cobbles (20%) / Loose angular / Moisture 10%
			Material in large cobbles
14

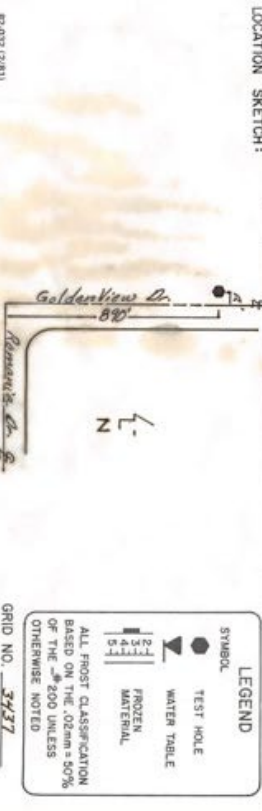
HOLE NO. 3
DATE 12/14/85
BY D.W. Miller
DEPTH 5.5'
WATER TABLE None

LOCATION Golden View Dr. 1/8 West of Golden View Dr.
800' North of E. Karamia Dr.
COMMENTS 3' after appeared in this area - all terminated in large cobbles between - 3' and - 4.5'

DEPTH	UNIFIED CLASS	FROST GROUP	DESCRIPTION
0			
3-4	SW/SM	F2	Excavation - Gravelly Sand (65%) (8%)
EX-505			Thin - Gravelly Sand w/ silt / Moisture = 4.5%
3-8	SW/SM	F2	Remain - Gravelly Sand w/ silt / Moisture = 4.5%
EX-506			Cobbles (20%) / High clayey
			Material in large cobbles
14
